EXECUTIVE SUMMARY

The Bridgewater Public Service Commission (PSC) initiated on June 19, 2000 a land use study to be conducted on the Petite Riviere Watershed, above Hebb Lake Dam. This area is also the water supply area for the Town of Bridgewater and a portion of it is designated a Protected Watershed Area (PWA). This implies regulatory controls to limit land use activities however, these controls are difficult to enforce. The study intended to identify historical and current land use activities which may be affecting or have the potential to affect the present water quality.

The Public Service Commission (PSC) of the Town of Bridgewater, Lunenburg County initiated on June 19, 2000 a land use study to be conducted on the Petite Riviere Watershed, above Hebb Lake Dam. This upper portion of the Petite Riviere Watershed provides the town's water supply, in particular Hebb, Milipsigate (also known as Leipsigate) and Minamkeak Lakes. The lakes and lands surrounding them are designated Protected Watershed Areas (PWA).

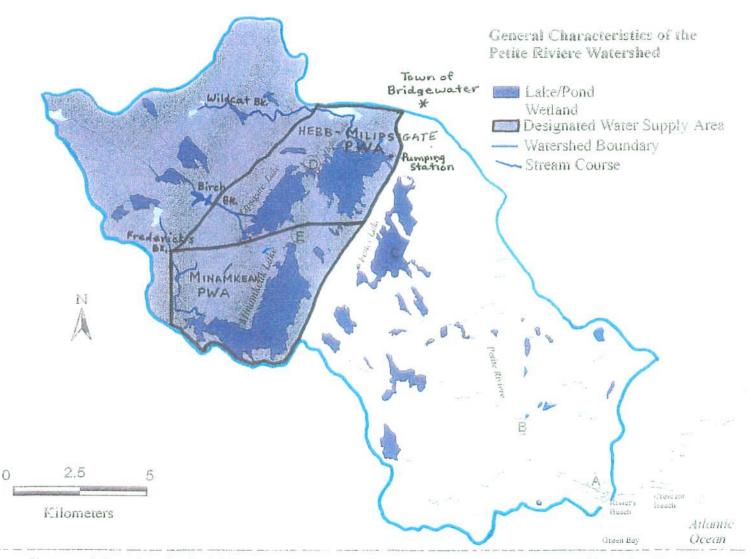
Figure 1 - Characteristics of the Petite Riviere Watershed. Source: Nova Scotia 1:50000 topographic series; 21 A/7, 21 A/8. (Sayah, 1999: copied and modified with permission)

The designated water supply (Hebb Lake watershed) for the Town of Bridgewater is a 110 km² area located west and southwest of the town (Figure 1). It is drained to the Atlantic Ocean by the Petite Riviere from an eastern point of Hebb Lake. Water flow from Minamkeak Lake was also directed to this point in 1939 by road and embankment upgrades to the south end of this lake, which prevented previous flow (Sayah 1999). The three lakes Hebb, Milipsigate and Minamkeak are fed by Wildcat, Birch and Frederick Brooks respectively. Water flow and lake levels are controlled by the Bridgewater PSC by a number of dams and water is drawn by a pumping station at the eastern, discharge area of Hebb Lake: A 100 series highway (103) borders and bounds the water supply area to the southeast, adjacent to Hebb Lake.

The watershed has a number of wetland areas scattered throughout (Figure 1). A wetland area is a basin that collects and holds runoff water by absorption. Wetland areas delay the discharge of runoff into streams and rivers. When filled to absorption capacity, they will begin to gradually discharge the water into the groundwater table or the closest streams or watercourses. The wetland can also filter out certain types of pollutants contained in runoff water such as organic matter, and dissolved metals such as arsenic are absorbed by marsh plants (Ripley, 1996). The wetlands are a constant source concerning the recharge of the groundwater.

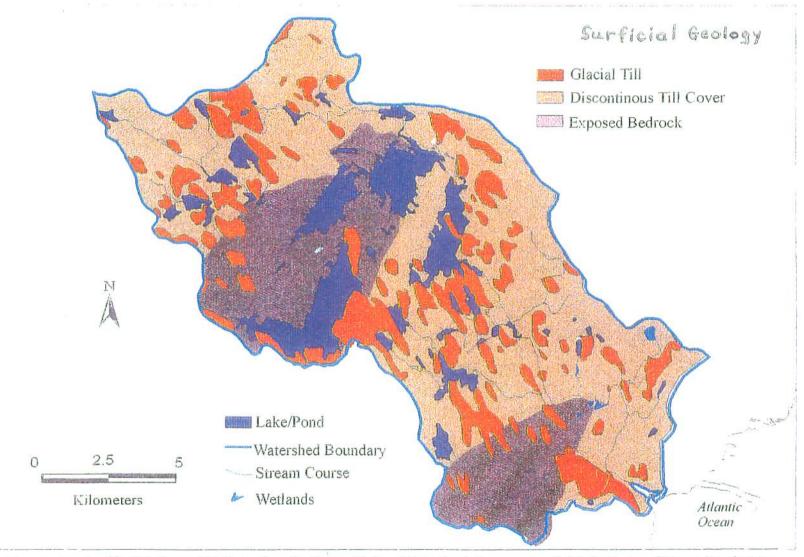
Figure 2 - Aquifer Media and Ratings for the Petite Riviere Watershed. Source: Surficial Geology of Nova Scotia Map 92-3, NS Department of Natural Resources Mines and Energy Branches, Halifax, Nova Scotia, 1992. (Sayah, 1999: copied and modified with permission)

Surficial geology (Figure 2) includes drumlins in the northwestern water supply area which support the agricultural land uses and are composed of glacially deposited mounds of till. Shallow, discontinuous till covers a large portion of the area and supports a forest ground cover. Bedrock is exposed throughout an equally large area and mostly underlies the lakes. The watershed area lies on the Meguma Group of bedrock consisting of the Halifax and Goldenville formations (Figure 3). The Goldenville formation underlying the lakes consists of black, grey and greenish grey quartzite layered with beds of bluish and greenish grey slates (Sangster, 1990). To the north and northwest the Halifax formation overlies the Goldenville and consists of black, grey and green slate and argillite.

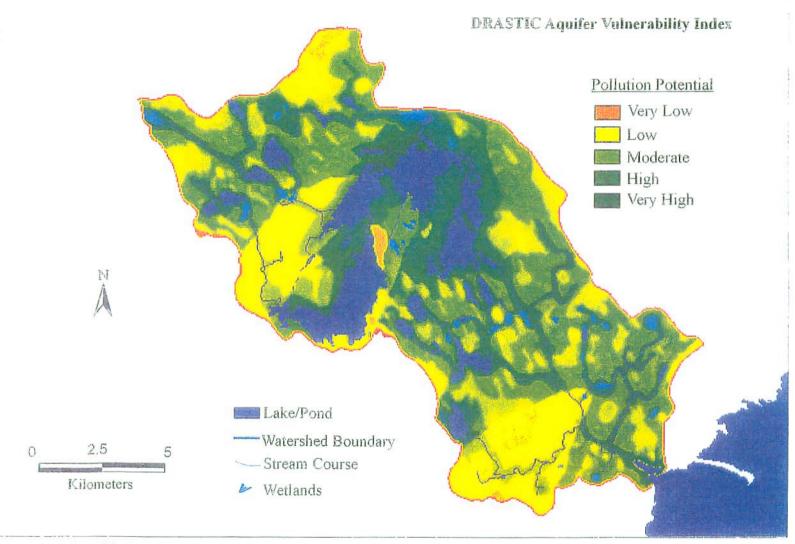
Figure 4- Modified DRASTIC Aquifer Vulnerability Index. based on topography, soil media, aquifer media, and depth to the watertable. Layers were overlayed and pixels added together using the Idrisi OVERLAY module (Sayah, 1999: copied and modified with permission)

Groundwater is an underground reservoir of water available for plant growth and also for sustaining the water levels in lakes, ponds and streams (Lunenburg County, 1980). Groundwater also has the ability to moderate the impacts of acid rain (Environment Canada, 1995) and can be affected by contaminants seeping into it. This may in turn pollute water bodies downstream. Dissolved material may diffuse through it or be carried along by it. Chemical changes can occur from reactions with neighboring rock and from solutes reacting with each other. Groundwater moves through fractures and cracks in the bedrock and, although specific hydrological data was not available in this regard, flow is determined by the connections within the fracture systems. The groundwater table surrounding the Lakes' area is fairly shallow (Sayah, 1999) and storage capacity is not known. It is believed that extensive past mining activities may have altered subsurface (groundwater) flow, particularly around the area of Milipsigate Lake. Previously impermeable bedrock may have been made permeable by the excavation of shafts, adits (tunnels) and rises and by the drilling and blasting practices of the time. This is also based on continual reference to fractured and weak rock zones encountered and referenced in assessment reports at the Mines and Energy Branch of the Department of Natural Resources. The interconnection of the groundwater table with the Lakes is not known but may be determined from further hydrologic study. Saide Sayah (1999) produced a Drastic Aquifer Vulnerability Index. It shows the potential for pollution of the groundwater aquifer to be high in the Lakes area, particularly between the three Lakes (Figure 4).

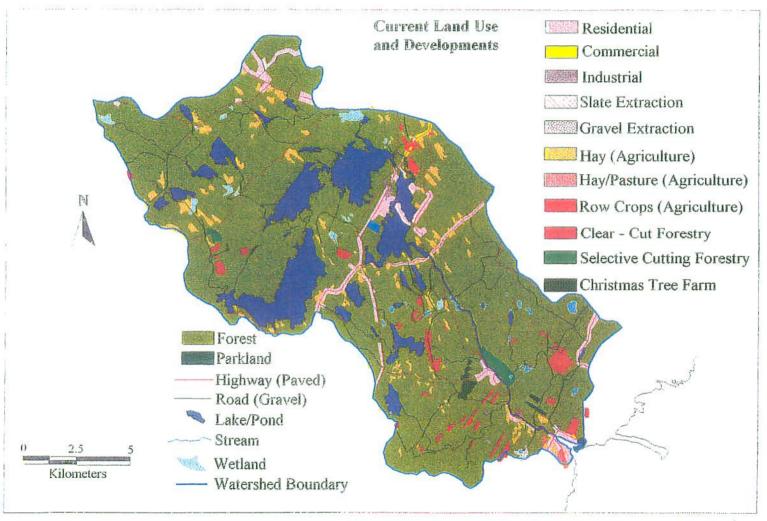
Figure 5 - Current Land Use and Activities (1999).

Agriculture is a dominant land use in the water supply area (Figure 5). It is practiced within the watershed boundary but outside of the Hebb-Milipsigate Lake, and Minamkeak Lake protected watershed areas. It mostly consists of hay fields scattered throughout and pasture land, mostly to the north in the upper reaches of the watershed. These areas do have some effect on the water quality by way of bacterial contaminants and siltation but do not pose a significant detrimental effect on the water supply. Chlorine treatment usually renders the potential problem abstract (Lunenburg County, 1980). The use of liquid manures in particular can contribute to contamination by allowing bacteria more mobility through runoff. Herbicide and pesticide use is a concern receiving more attention lately but is limited to a few areas (Sayah, 1999). A U-pick strawberry operation is located north of Newcombe Lake and small rotational crops (corn) are also grown in the vicinity. The largest identified farms are two beef cattle operations, one north of Newcombe Lake and one west of the boundary between the two PWA's. Both are outside of the PWA (areas). A mid-size pig farming operation is located west of Minamkeak Lake and is also outside the protected area.
